Manhole Inspection Summary

Manhole # S43G__015MH

Location Address: **1601 e pratt st**

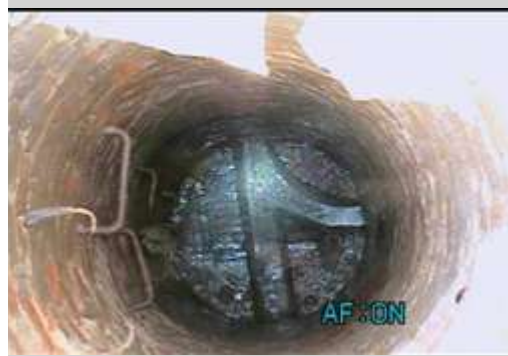
Top View

top view & steps

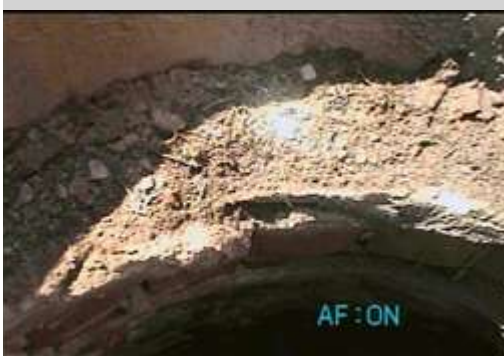
Defect 1

Offset: **6** (in.)

offset

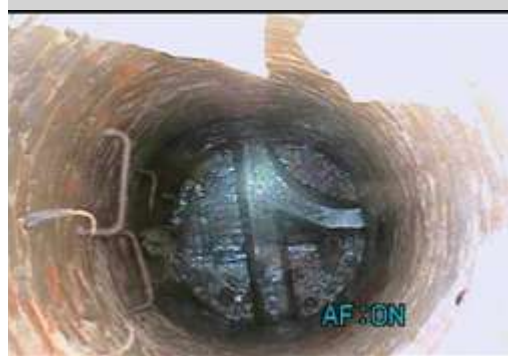
Defect 2

Count: **6** Missing: **2** ☒ **Corroded**

steps_missing_2, corroded

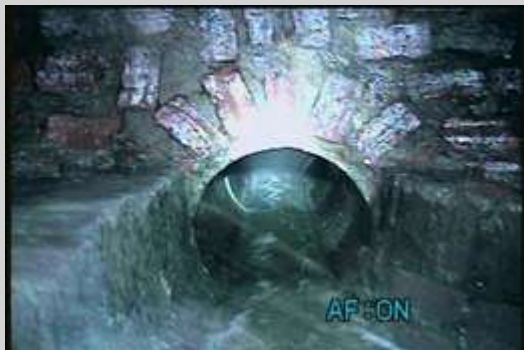
12 O'Clock Outflow

8 in. Circular Gravity Sewer
Pipe Out @ 12 O'Clock

Pipe Material: **Clay** ☐ Pipe Lined

Invert Depth: **13.13** (ft.) Flow Characteristics: **Fast**

Deposits: ☒ None ☐ Mud ☐ Sludge ☐ Debris ☐ Grease

Infiltration: **None** Pipe Seal Cond: **Unknown**

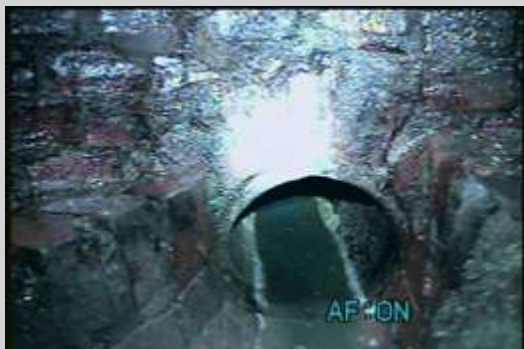
3 O'Clock Inflow

8 in. Circular Gravity Sewer
Pipe In @ 3 O'Clock

Pipe Material: **Clay** ☐ Pipe Lined

Invert Depth: **13.10** (ft.) Flow Characteristics: **Fast**

Deposits: ☒ None ☐ Mud ☐ Sludge ☐ Debris ☐ Grease

Infiltration: **None** Pipe Seal Cond: **Unknown**

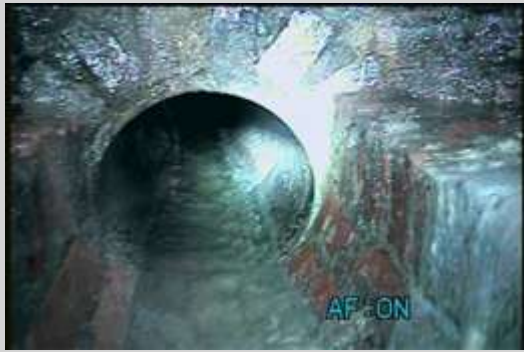
6 O'Clock Inflow

8 in. Circular Gravity Sewer

Pipe In @ 6 O'Clock

Pipe Material: **Clay** ☐ Pipe Lined

Invert Depth: **12.84** (ft.) Flow Characteristics: **Fast**

Deposits: ☒ None ☐ Mud ☐ Sludge ☐ Debris ☐ Grease

Infiltration: **None** Pipe Seal Cond: **Unknown**

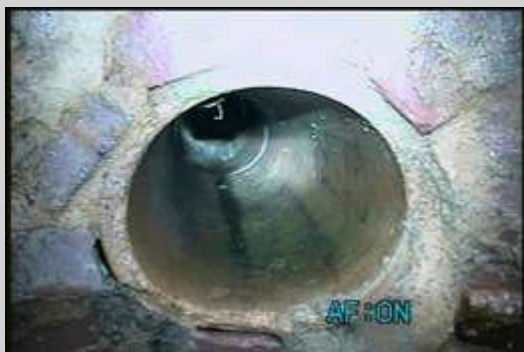
9 O'Clock Inflow

8 in. Circular Gravity Sewer

Pipe In @ 9 O'Clock

Pipe Material: **Clay** ☐ Pipe Lined

Invert Depth: **7.15** (ft.) Flow Characteristics: **Fast**

Deposits: ☒ None ☐ Mud ☐ Sludge ☐ Debris ☐ Grease

Infiltration: **None** Pipe Seal Cond: **Unknown**

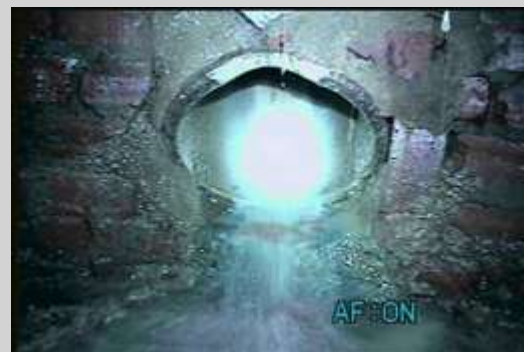
Drop In @ 9 O'Clock

Drop: **Outside Direct**

Inv Depth: **12.80** (ft.)

Drop Condition: **Open**
